Manhole Inspection Summary

Manhole # S13EE2030MH

Location Address: **2110 WESTERN RUN DR** Cross Street: **EASTCLIFF DR**

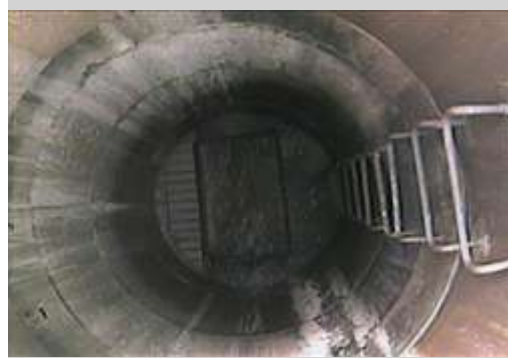
Top View

Corbel infiltration.

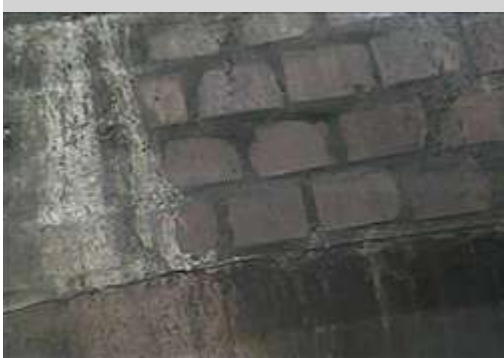
Defect

Adjustment infiltration - other side.

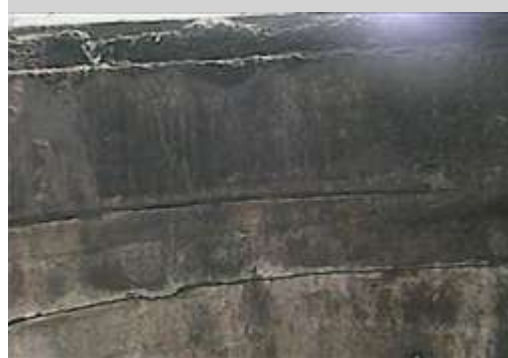
Defect

Adjustment infiltration.

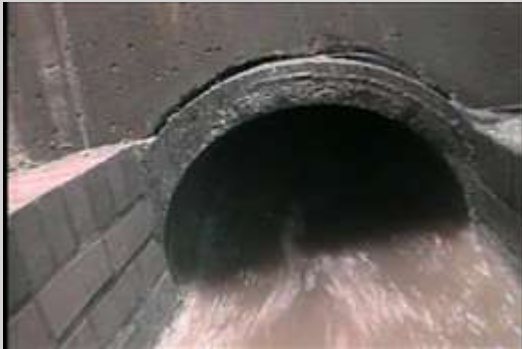
21 in. Circular Gravity Sewer Pipe Out @ 12 O'Clock

Infiltration: **Evidence** Pipe Seal Cond: **Unknown**

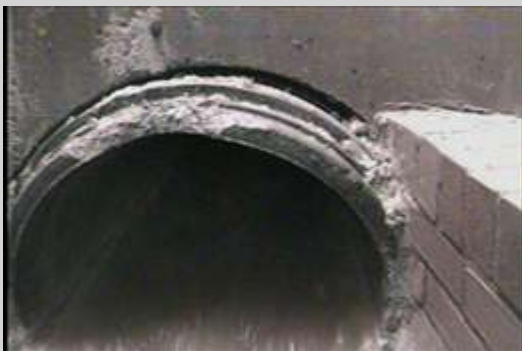
21 in. Circular Gravity Sewer Pipe In @ 6 O'Clock

Infiltration: **Evidence** Pipe Seal Cond: **Unknown**
